W-T MECHANICAL / ELECTRICAL ENGINEERING, LLC

December 31, 2008

Pursuant to your request the following is an existing conditions building report for mechanical, electrical and plumbing systems at St. Gregory Episcopal Church.

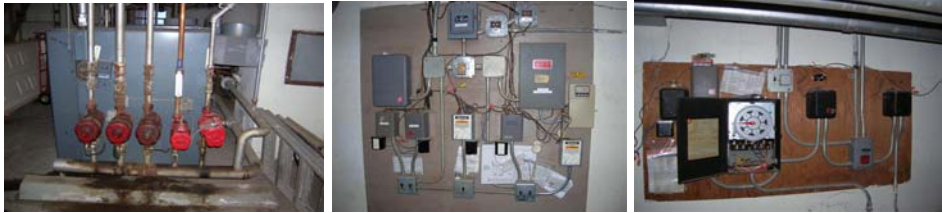
Basement Boiler Room Condition

This space contains two Weil-McClain hot water boilers, 816 Mbh output each. The boilers are approximately 50 years old and in fair condition, however, they are at the end of there expected life and increasing repairs and maintenance can be expected. The boilers serve seven (7) zones, 1-parish hall/ kitchen, 2-west wing & south, 3-offices/ guild room/ toilets/ hall, 4-Father office, 5-second floor office, 6-church, 7-acolyte room/ sacristy. Each zone has an inline pump that is controlled by a wall-mounted thermostat in the zone. Four of the pumps appear to be relatively new and in fair condition, the remaining three are in poor condition, one pump was severely leaking at the time of the survey. It appears that the zones were once controlled by timeclocks, these would allow the pumps to operate only during certain periods of the day the timeclocks have since been abandoned. The boilers have controls to adjust the supply water temperature based on the outside air temperature. At the time of the survey, some of the zones were not heating properly reportedly due to excessive air in the system. Service personnel were working on the problem. No chemical feed or filter systems were observed. There is little to no insulation on the hot water piping.

Combustion air openings were not observed near the boiler and the combustion air opening in the mechanical room to the north is not large enough to serve the boilers and furnaces.

Replace existing boilers with high efficiency boilers with sealed combustion. Provide a primary-secondary piping arrangement with an air separator; side stream filters and chemical feed

system. Provide dual secondary pumps with variable speed drives, provide individual zone valves controlled by the zone thermostats. Provide insulation on all hot water piping.

The payback for the new boilers should be relatively short due to the greater efficiency. Other advantages are better temperature control, much smaller footprint, and sealed combustion would eliminate the need for combustion air intakes

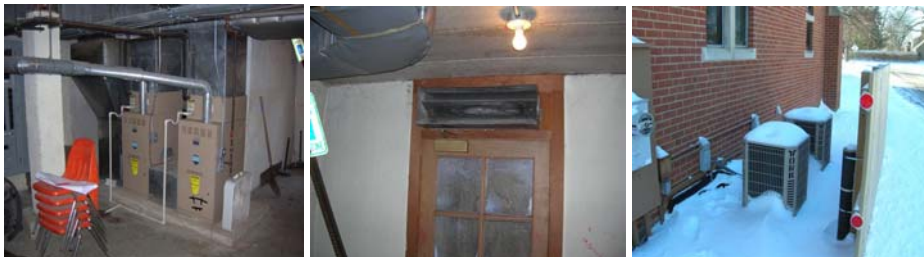
Basement Mechanical Room Condition

This space contains two York gas fired furnaces with refrigerant cooling coils. The associated 3.5-ton condensing units are located on grade north of the Chapel. Furnaces serve the west half of the Sanctuary and Bride's Room. 30"x8" combustion air opening above exterior door with manual damper. The furnaces and condensing units are approximately 10 years old and in fair condition, the condensing units have some corrosion damage at the bases.

Recommendations
Provide automatic damper on combustion air opening to open when furnaces are operating, this will reduce the heating and cooling load to the building.

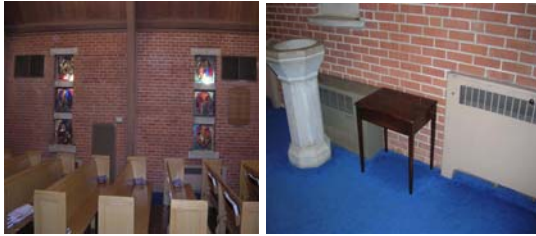
Nave
Condition

This room contains cabinet heaters, wall mounted supply and return grilles from furnaces in basement, wall mounted thermostat. Wall grilles are in good condition. Cabinet heaters are in fair condition.

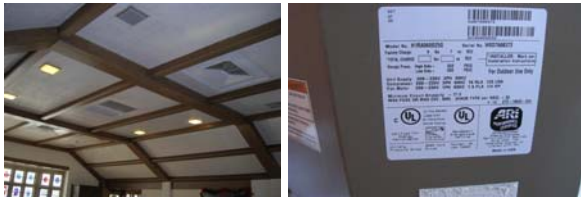
Founders Hall

This room contains cabinet heaters, ceiling mounted diffusers and grilles and wall-mounted thermostats. Heaters are in fair condition. Ceiling diffusers and grilles are in good condition. This space is heated by the hot water cabinet heaters and cooled by two (2) fan coil units located above the ceiling. These fan coil units (fcus) are cooling only with a refrigerant coil and associated 5 ton condensing units on grade east of the kitchen. Access to the fcus is thru the second floor apartment. The fcus are approximately 10 years old and in fair condition, the condensing units were replace approximately 2 years ago and are in good condition.

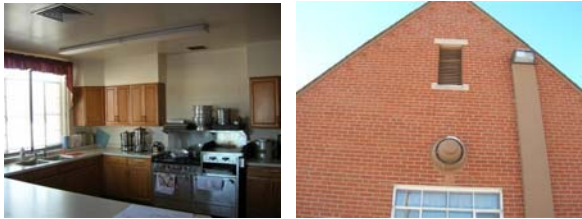
Kitchen

This room contains a ceiling mounted supply diffuser, cabinet heater, ceiling exhaust grille connected to exterior wall mounted exhaust fan. Cabinet heater mounted behind sink cabinets with grille openings on counter. A wall switch controls the exhaust fan, fan is noisy. Supply diffuser provides cooling, connected to fan coil unit.

Commercial cooking equipment requires commercial grease exhaust hood with fire suppression system.

Provide commercial exhaust hood and wall mounted exhaust fan.

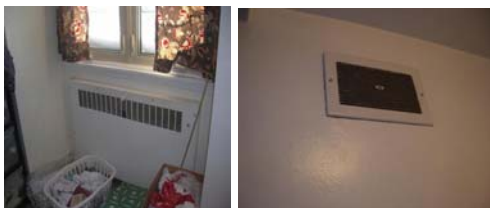
Sexton Apartment

The apartment contains baseboard heaters, wall mounted exhaust grille in kitchen, ceiling mounted exhaust fan in bathroom, and a wall mounted zone thermostat. The apartment has removable window mounted air conditioners; these are removed during the heating season. Baseboard is in fair condition, however, due to air in the hot water system some heaters were not operating. Exhaust grille in kitchen clogged with grease.

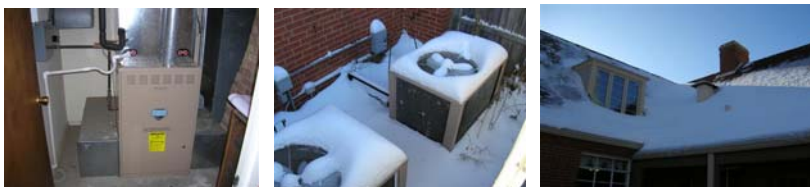
Furnace room

This room contains a gas fired York furnace with a refrigerant cooling coil. The associated 5-ton condensing unit is located on grade east of Chancel. This unit serves the second floor (except Sexton Apt). Furnace and condensing unit are approximately 10 years old and in fair condition. Combustion air is ducted into room from roof intake hood.

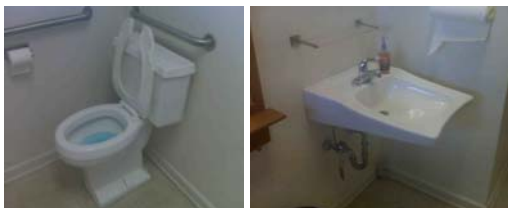
Men's Toilet

One (1) set tank type water closet, one (1) wall hung lavatory with dual handle faucet. Fixtures appear to be in good condition.

No floor drain, no temperature mixing valve on lavatory, no pipe insulation on lavatory, no offset waste on lavatory.

Correct code violations and maintain fixtures as required.

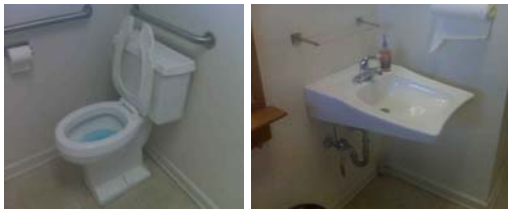
Women's Toilet

One (1) set tank type water closet, one (1) wall hung lavatory with dual handle faucet. Fixtures appear to be in good condition.

No floor drain, no temperature mixing valve on lavatory, no pipe insulation on lavatory, no offset waste on lavatory.

Correct code violations and maintain fixtures as required.

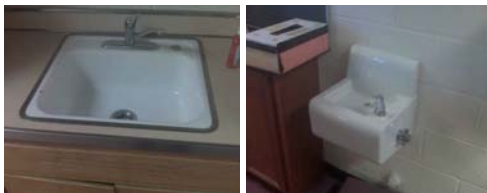
Corridor

One (1) single bowl sink with single handle faucet, one (1) china drinking fountain.

Drinking fountain not ADA compliant.

Correct code violations and maintain fixtures as required.

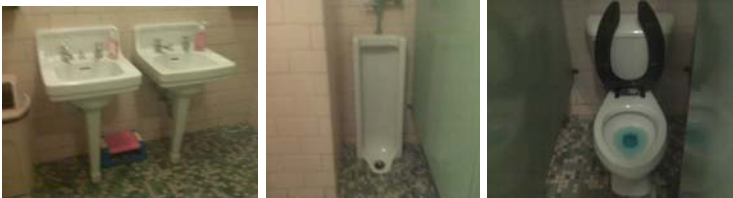
Boy's Toilet

Two (2) floor set water closets, one (1) urinal, two (2) wall hung pedestal lavatories with dual handle faucets. Fixtures appear to be in fair condition.

No ADA compliant fixtures, no floor drain.

Correct code violations and maintain fixtures as required.

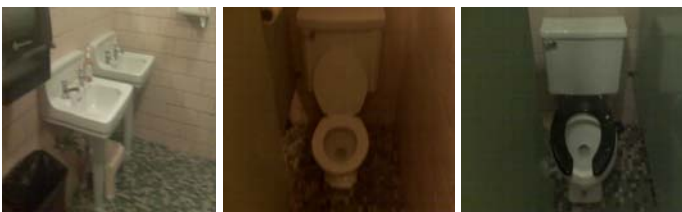
Girls Toilet

Two (2) floor set tank type water closets, one (1) floor set tank type baby bowl water closet, two (2) wall hung pedestal lavatories with dual handle faucets. Fixtures appear to be in fair condition.

No ADA compliant fixtures.

Correct code violations and maintain fixtures as required.

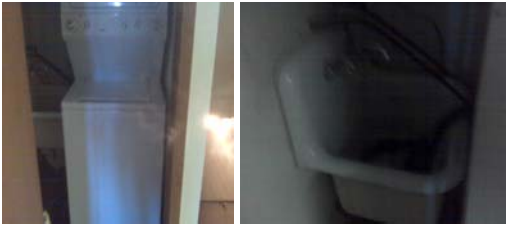
Janitor Closet

One (1) service sink with dual handle faucet, one (1) washing machine. Fixtures appear to be in fair condition.

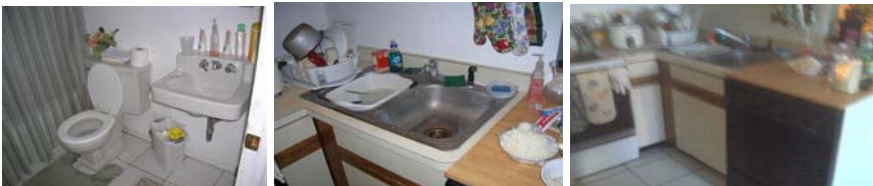
Sexton Apartment

One (1) floor set tank type water closet, one (1) wall hung lavatory with dual handle faucet, one (1) bathtub with dual handle valve, spout and head, one (1) double bowl stainless steel sink with single handle faucet and spray, One (1) dishwasher. Fixtures appear to be in fair / poor condition.

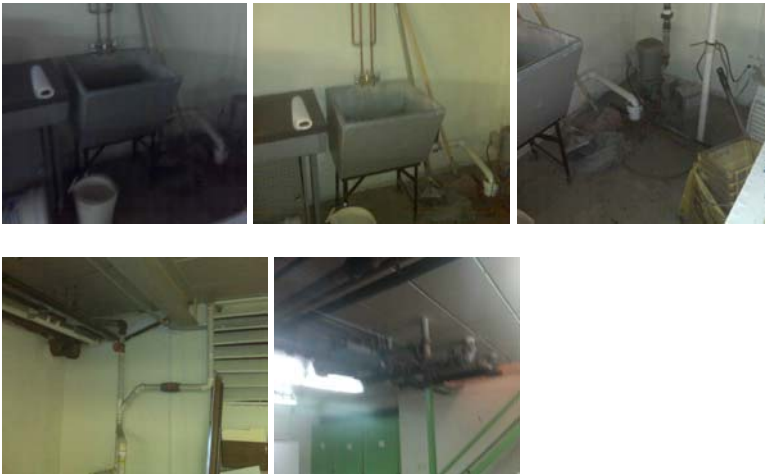
Boy Scouts

One (1) concrete laundry tub with dual handle faucet, one (1) simplex sump pump. Fixture and equipment appear to be in fair condition.

Laundry tub drains into sump pump, no vent pipe for laundry tub.

Correct code violations and maintain fixtures / equipment as required.

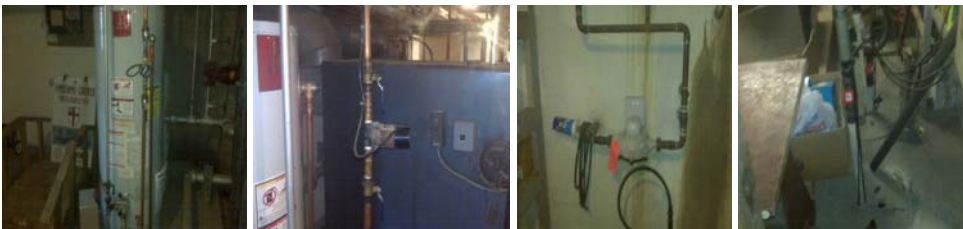
Boiler Room

One (1) 1 1/4" domestic water service, one (1) 1" water meter, one (1) 50 gallon 40,000 BTU water heater, one (1) cold water boiler feed, one (1) hot water recirculation pump, two (2) simplex sump pumps, one (1) floor drain. Equipment appears to be in good condition.

No reduced pressure backflow preventer on water service, no expansion tank on water heater, no backflow preventer on boiler feed.

Correct code violations and maintain equipment as required.

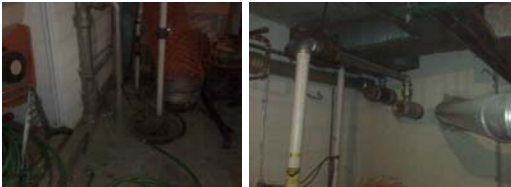
Mechanical / Electrical Room

One (1) simplex sewage ejector, one (1) simplex sump pump, one (1) floor drain. Equipment appears to be in good condition.

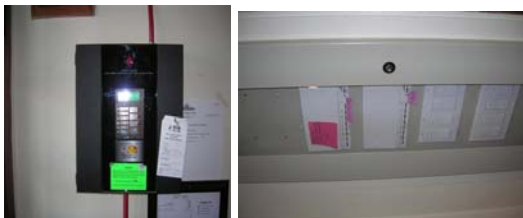
Sacristy

Fire alarm control panel located in south wall at entry door #8, smoke detector located above FACP. Lighting 4 foot 4 lamp T12 fluorescent wraparound, leviton lighting controls for sanctuary located in corridor next to sacristy door.

The equipment is in good condition.

Add exit signs, emergency lighting, smoke detectors in offices, add visuals in men and women's toilets.

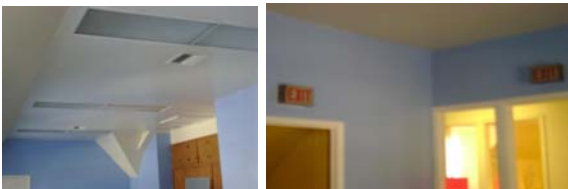
Youth Room

Six (6) 2' x 4' recessed 4 lamp T12 fluorescent troffers, two (2) wall switches at door, two (2) one foot square recessed incandescent fixtures at closet doors with one (1) wall switch, two (2) exit signs over doors, one (1) foot square recessed incandescent fixture with wall switch at entrance to Archive room. Three (3) duplex receptacles on west wall, two (2) duplex receptacles on north wall, two (2) duplex receptacles on east wall.

Replace exit sign with Led type with built in 90 minute battery back up thru out space.
